FACILITY COMPLIANCE INSPECTION REPORT

Division of Waste Management Solid Waste Section

Chatham County Permanent Household Hazardous Waste Collection Facility
726 County Landfill Road
Pittsboro, NC 27312

Comprehensive Audit

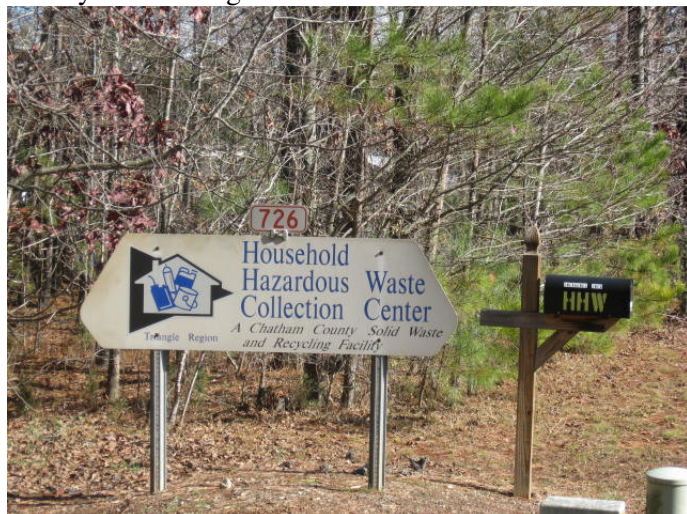
28. The site is secured by chain link fence and locked gate.
29. The facility has proper signage.
30. The permit expiration date is October 21, 2015.
31. Permit renewal application shall be submitted to the SWS by April 21, 2015.

Facility entrance sign

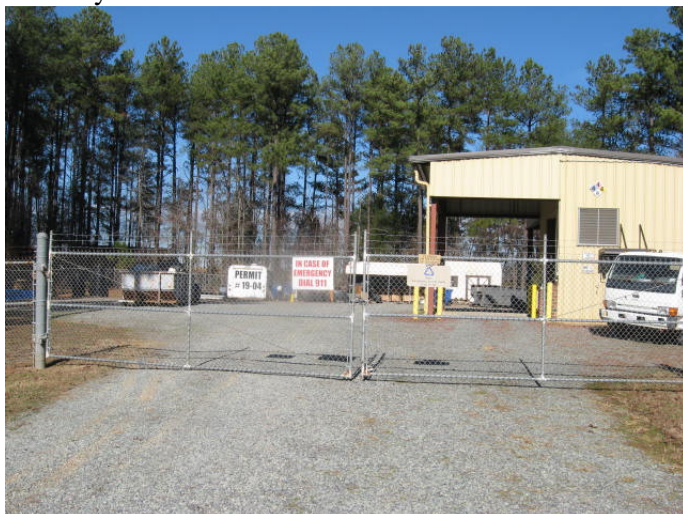
Facility entrance

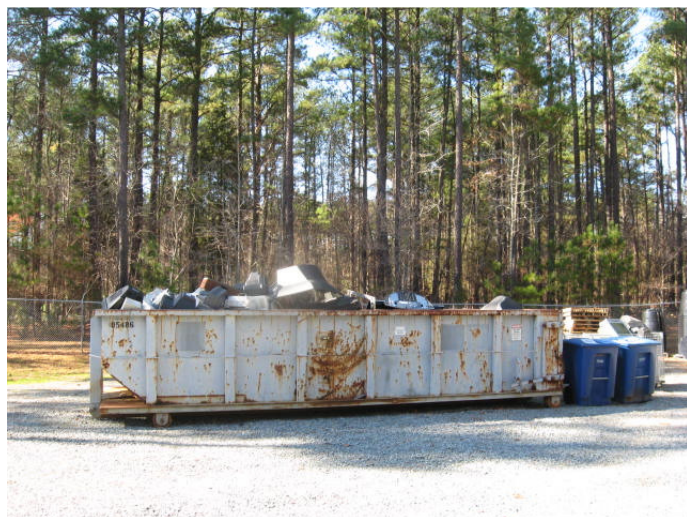
22. The facility receives fire extinguishers, propane tanks, used oil, and electronics (televisions and computers) throughout the year, stored outside until hauled-off.

Television and computer storage

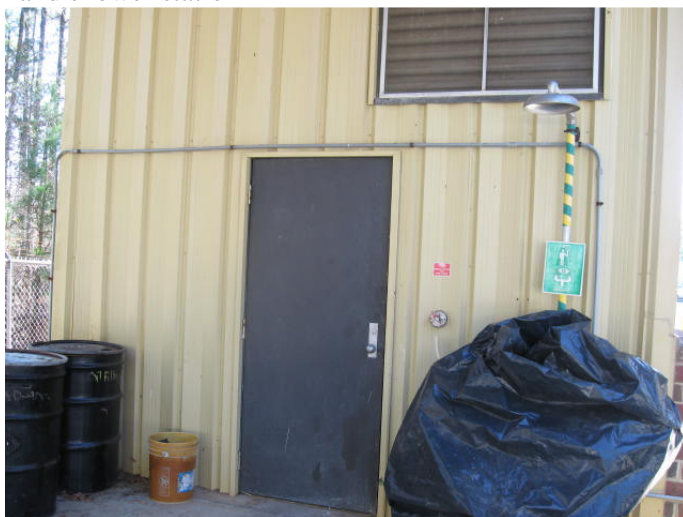
18. The facility has an emergency eyewash and shower station located adjacent to the storage building entrance, atop the concrete pad.
19. During the audit the facility did not have HHW stored on site. An accumulation label was affixed to a 50-gallon drum of alkaline batteries, dated October 31, 2011. Ms. Chapman stated that accumulated material, if stored on site, is routinely stored ~ 90 days.

Storage building entrance door and emergency eyewash and shower station

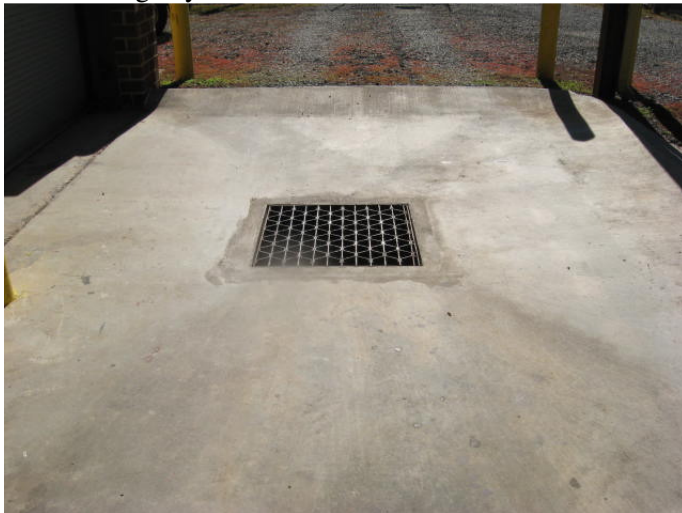
10. The facility has a small storage building with a secondary containment sump and automatic fire suppression system. Outside of the storage building there are two concrete pads, each with a secondary containment sump, covered by an all-weather awning.

11. Mr. LaMontagne stated that prior to a collection event stormwater is pumped-out of the outdoor secondary containment sumps. And that the outdoor secondary containment sumps, if utilized during a collection event, will be cleaned accordingly such that stormwater (collected in the sumps) is not contaminated.

Containment sump adjacent to storage building garage door/loading bay

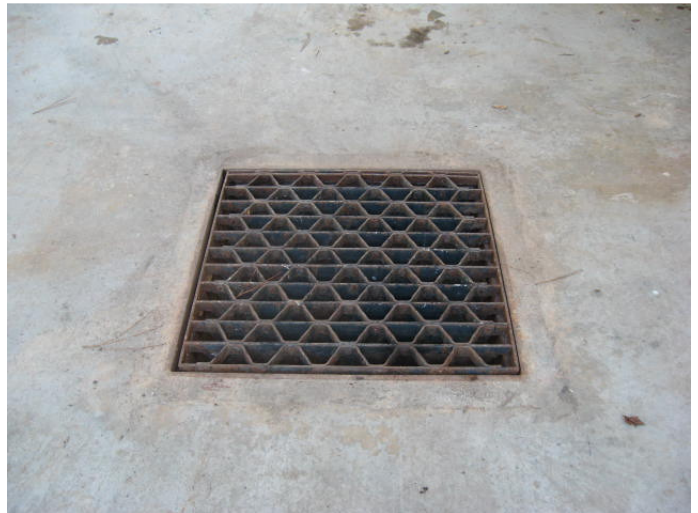
Containment sump adjacent to storage building entrance door

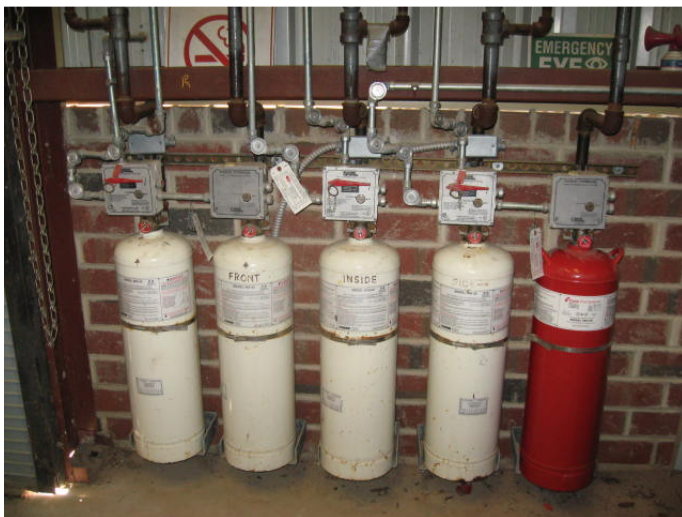
24. The annual Chatham County Fire Marshal inspection was conducted on November 30, 2011.
25. The T&S Fire and Security, Inc. semi-annual fire suppression system inspection was conducted on May 11 and November 15, 2011.

Storage building fire suppression canisters

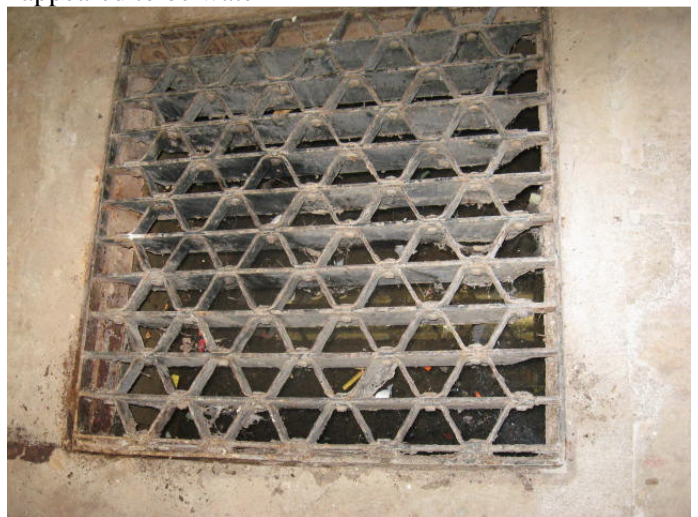
12. The secondary containment sump inside the storage building is in need of repair – it has filled with what appeared to be water. Ms. Chapman stated that the containment sump will be repaired ASAP. Ensure that the facility does not place material in the storage building/conduct a collection event prior to its repair.

Storage building containment sump (located inside building) in need of repair – filled with what appeared to be water
